VILLA ACQUATERRA

LIFE CYCLE ASSESMENT

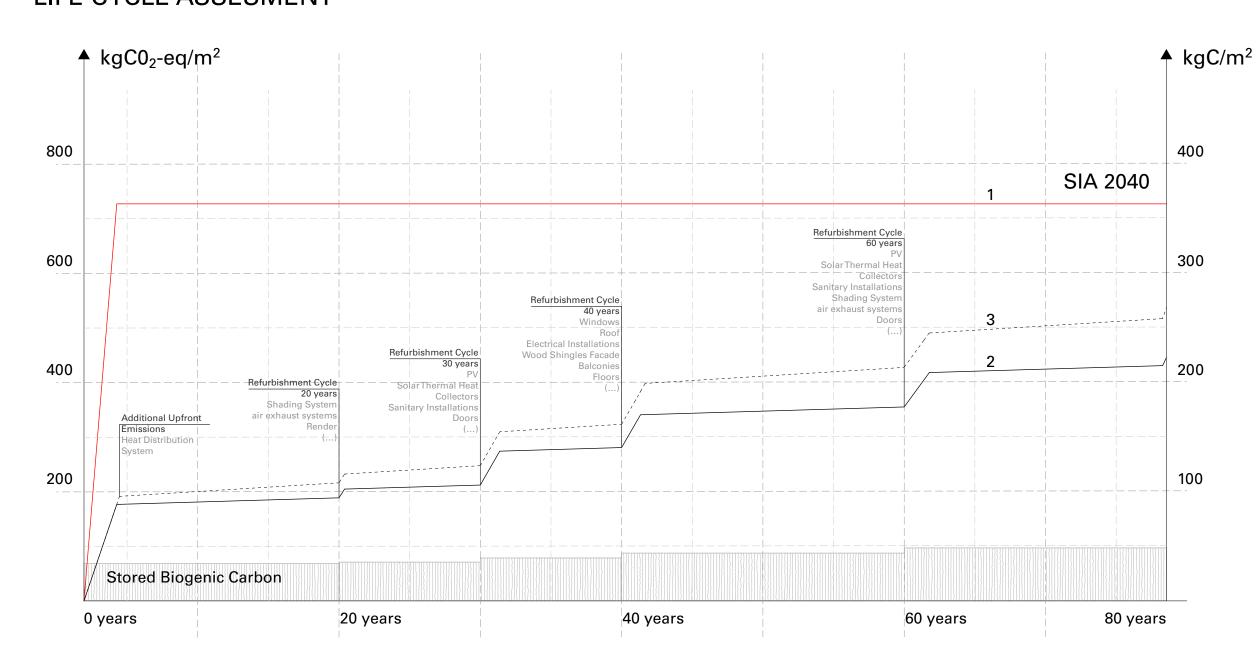
Explanatory Notes

- SIA 2040 Life Cycle Values, Refurbishments being accounted for in the Upfront Emissions (red line)
- Villa Acquaterra with Trombewall System (black solid line)
- Villa Acquaterra without Trombewall System Heat supply by local district heating (black dashed line)

Refurbishment Cycles: Refurbishments are sorted in order of magnitude/impact of kgCO₂-eq per m²
